Final Report

Scotia-Glenville Central School District

Athletic Fields Master Plan

Chazen Project No. 31688.00

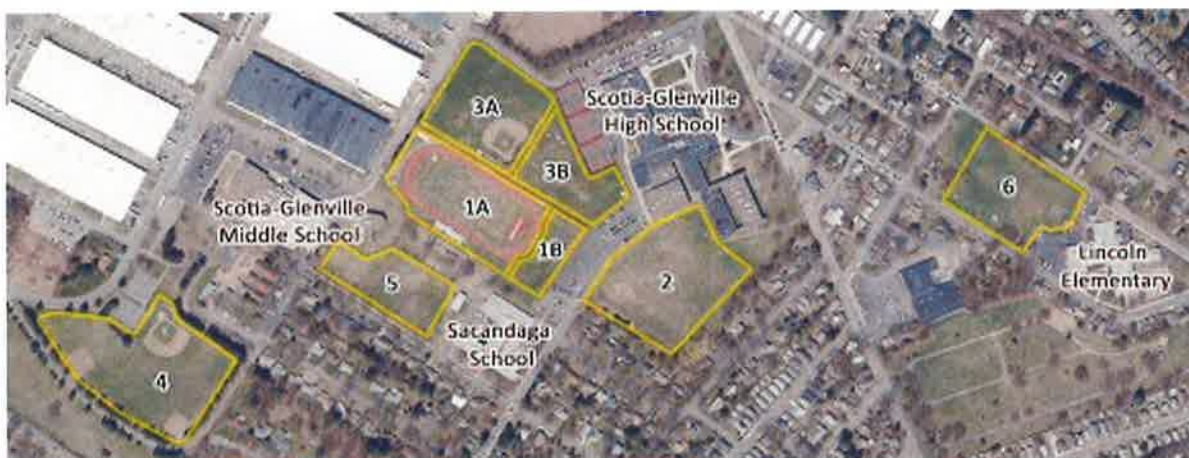
Figure 2.1

During our site visit, Chazen examined the active recreation areas listed below. We organized areas into numerical groups for reference. **Figure 2.1** below illustrates each of these groups.

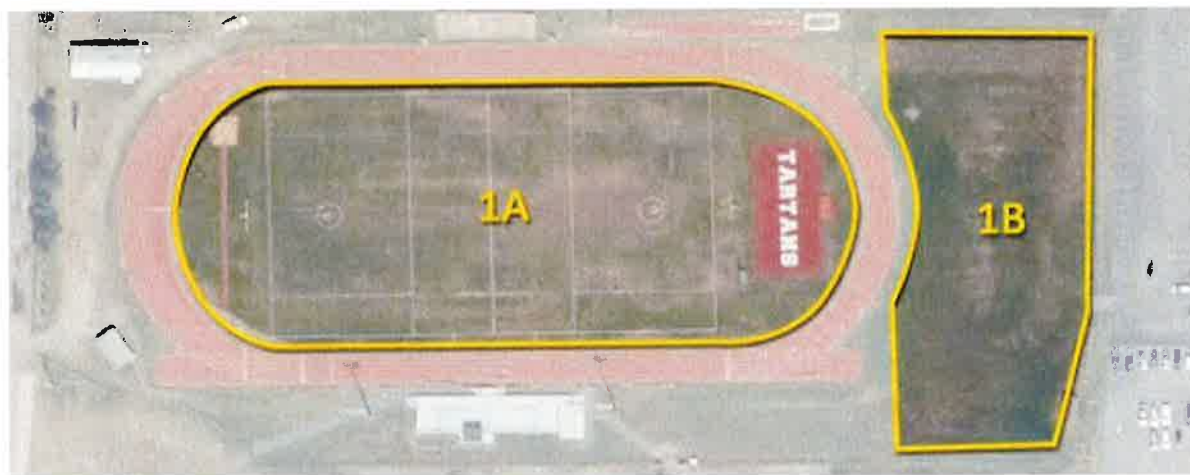
- The turf main field (1A) is in fair condition due to having an irrigation system though there are several areas which are not level and/or have turf which is worn.

- The turf of Practice Field (1B) is not irrigated and the turf is patchy to poor and shows significant wear.
- The crown of the main field is inconsistent and is not optimal.

- The irrigation system on the main field is operational however in order to amend the soil and re-grade the surface for optimal playing conditions would require replacement.

- The lighting of the main field is adequate and in good condition.
- The existing scoreboard is in poor condition.
- Track is in good condition for practices and meets however will eventually require resurfacing.

- The Home Grandstands and press box are in good condition. Visitor bleachers are in good condition.
- Perimeter fence is inconsistent, varying from good to poor condition.

The most significant upgrade would be the field itself. Given the grading issues and the age of the current irrigation system Chazen recommends field reconstruction consisting of amending the soil, grading and re-crowning of the field as per the standard set by the NFHS (National Federation of State High School Associations) and sodding. We recommend installing sod vs. seeding the field which would result in reduced loss of play associated with turf establishment. Concurrent with the re-grading and sodding of the field, Chazen recommends removing

and replacing the current irrigation system as well as inspecting/cleaning the existing drainage structures to ensure their proper operation for conveying surface water runoff.

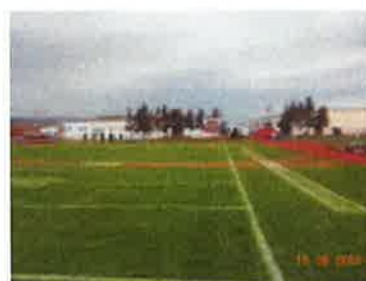
Field 1A (Main Field):

- Football Games (All levels)
- Track and Field Meets and Practices (All levels)
- Varsity Boys Lacrosse
- Varsity Sports Special Events (Girls and Boys)
 - Once per season all soccer, and girls lacrosse and field hockey teams play a single game on the main field.

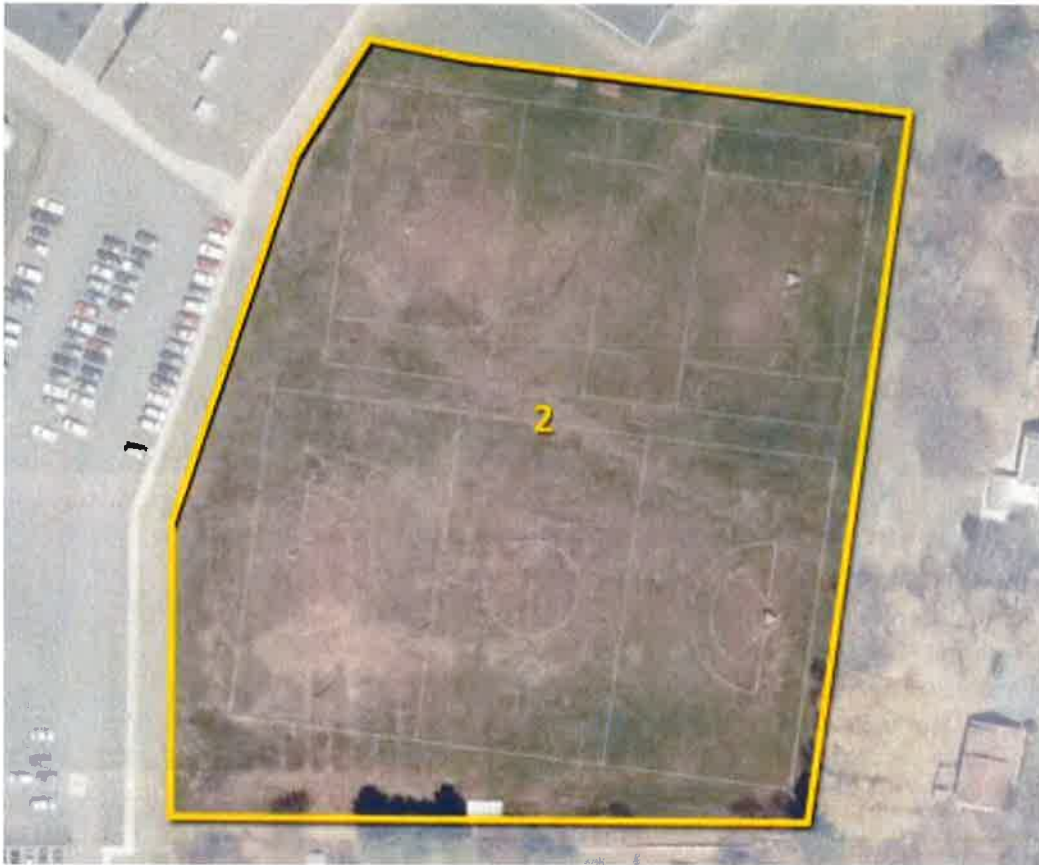
The turf is in poor condition and comprised primarily of non-grass species that show patches of bare sandy soil. The grading of the fields is generally good except for the northern field hockey goal locations where the goalie zone is lower than the surrounding field play area. Overall the area lacks a perimeter fence for controlled access. Field area is generally void of bleacher / spectator seating, given orientation changes desirable to be portable. Given orientation of fields for lacrosse the potential exists for property damage and / or game delays due to errant balls on the east side of the property. There currently is no permanent scoreboard for either lacrosse or field hockey, one currently on the corner face of the school is old, doesn't function and will be removed.

Field area - The current field is very heavily used, therefore Chazen recommends soil amendments and the installation of an irrigation system. Although the grades of the fields are not poor there are a few locations where the goals are not located on level planes with the surrounding shooting area – these areas should be re-graded with minimal fill to provide a more uniform, consistent pitch. Due to the heavy use of the field we also recommend the

Field surround – We recommend the installation of a 4' perimeter fence along the parking area to control access (given that this field hosts field hockey and lacrosse sporting events which require paid admission) and provide increased safety between the vehicular area and the play area. The east and south sides of the field are void of a perimeter fence separating the fields from the neighboring residential properties. It is recommended that a 4'-6' high chain link fence be installed with a single gate location along each leg for protection against errant balls and potential

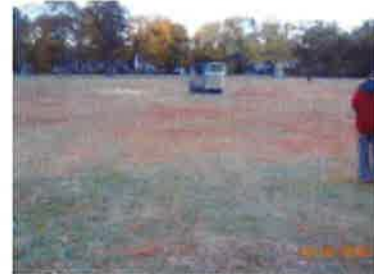
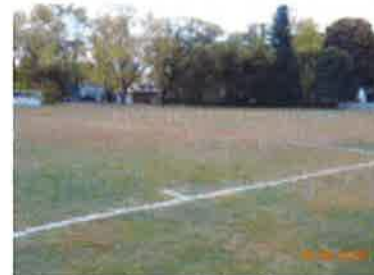
There is no controlled access to the field for practice or games. For games, the absence of controlled access points caused ticket sale issues and / or makes crowd control impractical.

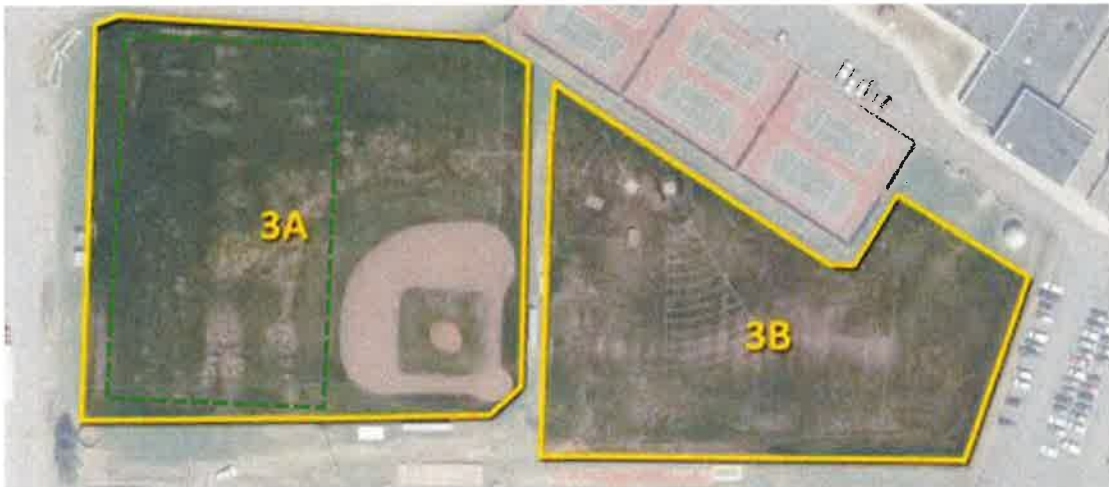
- The turf on Field 3A is in fair condition due to having an irrigation system though there are several areas which are not level and/or have turf which is worn.

- The irrigation system on Field 3A is older, partially functional and would require replacement with grading improvements.
- The turf on Field 3B is not irrigated and the turf is patchy to poor and shows its wear with some sections of bare sand.

- The baseball field is currently in poor overall condition, with several grading issues. The interface between the grass areas and clay/dirt infield has lips and dips which is potentially hazardous. There is a significant grading difference between the infield and outfield on the first base side.

Chazen recommends a complete replacement and reconstruction of the baseball and soccer fields for optimal play and solar orientation (shown on the figure to the right and in Appendix B). Generally speaking the entire baseball portion of the field is showing wear, has significant grading issues, and undesirable North-West orientation (see 'Field Orientation' in Section 2.4). Chazen concluded that it is best to relocate the baseball field to the west side of the field area and reoriented to the optimal Northeast alignment. This is a complete overhaul consisting of a new beam clay infield, dugouts, backstop and fencing. Along the western property line of the industrial park it is recommended that an extended ballstop netting be installed to protect batted balls from falling on the industrial park access road and buildings.

The existing chain link fence with barb wire at the top, bordering the industrial park, is unattractive and is recommended to be replaced with a new 8' high black PVC coated chain link fence with privacy slats. We recognize there is a potential fence ownership issue we are aware of that would need to be negotiated with the industrial park for this to occur.

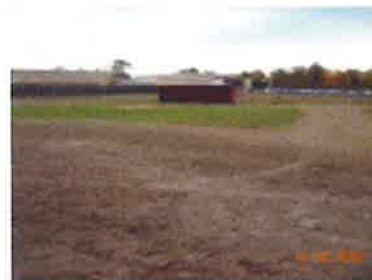
Field 3B:

- Football Practice
- Lacrosse Practice
- Track and Field Meets and Practice

The main need for field 3B is the installation of an irrigation system as the turf is inadequate due to the sandy soils found throughout the site. Some spot grading would also be beneficial, and finally the replacement of an antiquated field goal post with a modern design would be beneficial as one of the main uses of the field is for football practice.

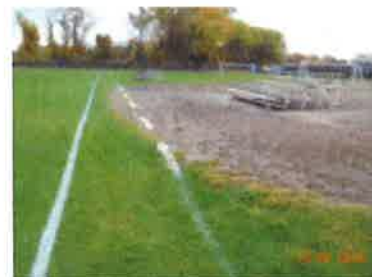
- The baseball backstop is in poor condition.
- The temporary spectator bleacher seating located on the baseball infield is not optimal leading to poor viewing opportunities for varsity soccer events (see photo above).

- The north-west to south-east orientation of the baseball field is not ideal due to sun glare.
- The barbed wire fence that borders the industrial park exhibits a negative aesthetic for students, spectators or athletes.

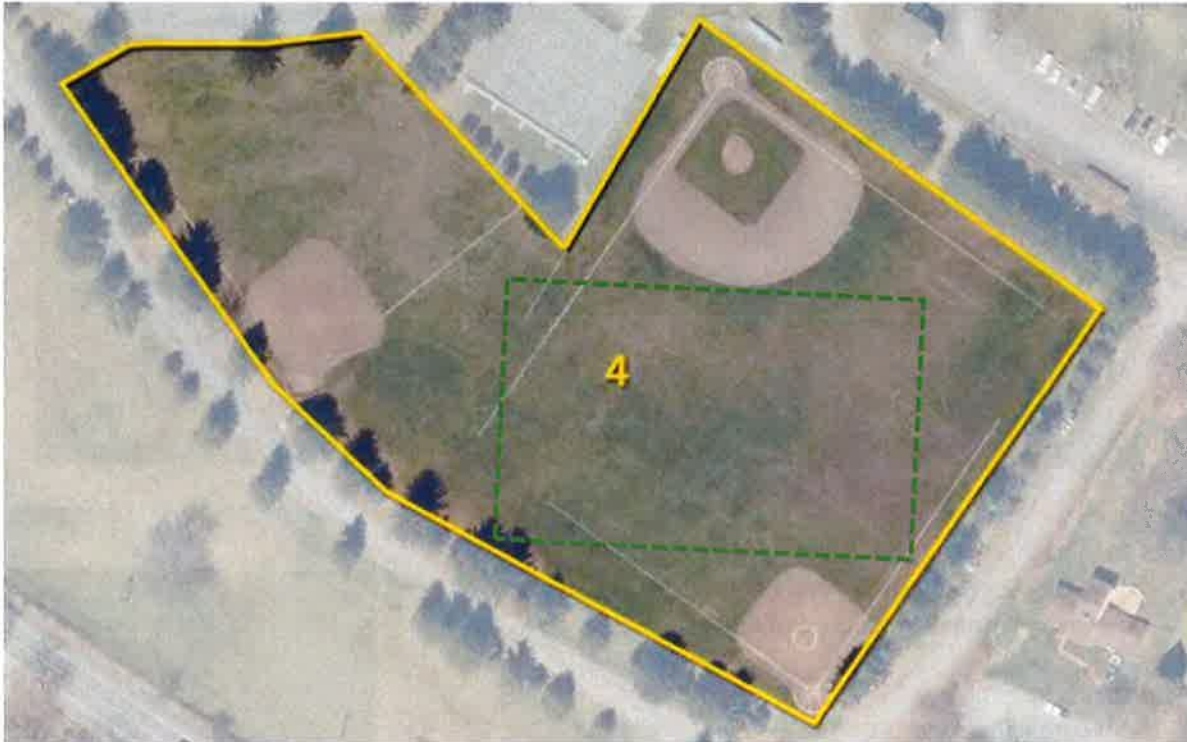
Turf is not irrigated thus is in poor condition and comprised primarily of non-grass species that show patches of bare sandy soil. Grading issues are common in this area, particularly the infield / outfield conditions of the baseball diamond and eastern softball field with grade differences of almost 2' in spots between the diamond and outfield areas. The soccer play area is located in the outfields of the baseball and softball practice fields and is poorly graded with significant variations in grade throughout. The bleachers, backstop and dugouts are in good condition for the baseball diamond. The south east softball field is void of dugouts, the backstop is in poor shape and the spectator seating is deficient. The western softball field has new dugouts, but the backstop is in poor condition and there isn't a permanent outfield fence.

Field 4A – Varsity Softball Field: The field is in fair condition, therefore the major objectives of the recommendations are to repair and establish a better grass turf as well as enhance the surroundings of the field. Similar to other fields, in order to establish a quality turf outfield, Chazen recommends installing a permanent irrigation system in the outfield, amending the existing topsoil and installing sod. For the infield portion Chazen recommends re-installing a beam clay surface as well as installing a new backstop to complement the new dugouts recently installed. In addition, a 4' chain link fence along the western tree line (along the parkway) would be beneficial for the safety of the athletes as the grade drops off substantially in that area.

Since the baseline recommendations for rectifying the significant grade issues would carry a substantial cost for earthwork and turf reconstruction, Chazen recommends relocating the JV baseball field to a location between the Varsity and JV softball fields, oriented home plate to pitcher's mound to the north east and shifting the modified soccer fields to the north. According to the Athletic Director it would be acceptable to have the outfields of the JV ball fields coincide as scheduling of those games and/or practices could eliminate the potential for play overlap. For the JV softball field it has been specifically identified that installing new dugouts and a 4' perimeter fence on the south side of the site above the slope along the tree line would be modest cost additions for JV softball.

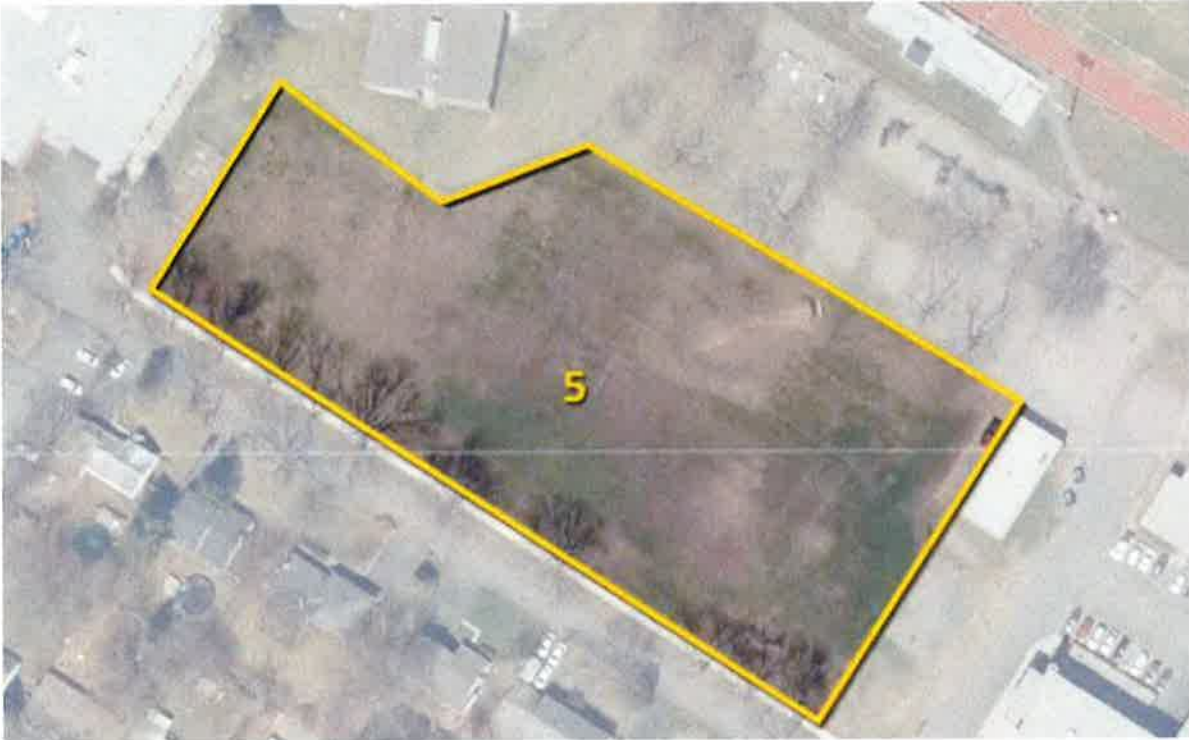
Turf is not irrigated thus is in poor condition and comprised primarily of non-grass species that show patches of bare sandy soil. Grading and drainage of the field appeared to be in good condition. The southern edge is bordered by a pedestrian sidewalk parallel to Wren Street, presenting the need for a safety barrier / fence to limit potential conflict with game and practice events.

As discussed in the Existing Conditions Evaluation (2.3.5), the main issue with this field is the condition of the turf, as the existing grades for the field play area are adequate. Given one of the main uses of this field is Modified Football a healthy and sustainable turf is necessary for player safety, for this reason Chazen recommends using a Water Reel Irrigator for this site in addition to soil amendments and replacing the turf

with sod over seed as this eliminates the possibility of competing weeds establishing along with the turf. The use of water reels is a lower cost recommendation as compared to in-ground irrigation and is commensurate with the lower intensity of use and wear placed on this field.

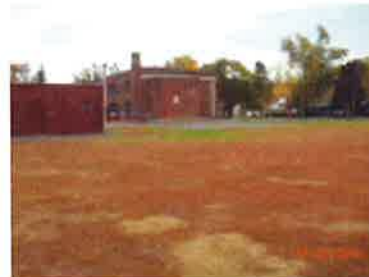
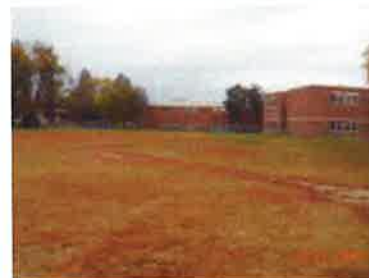
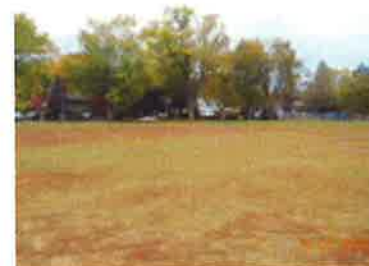
Easily accessible for students and nearby residents, perhaps too accessible for residents as there is no perimeter fence to control access.

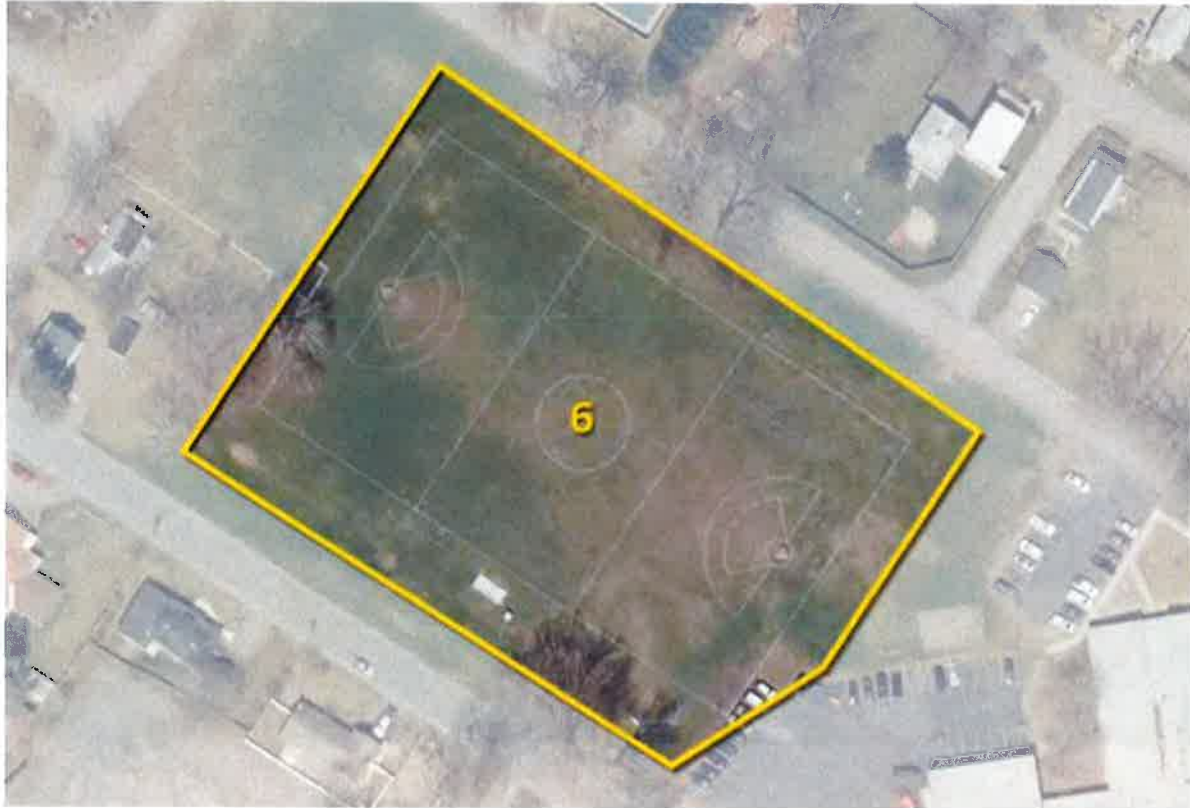
Turf is not irrigated however it is in fair condition with some non-grass patches visible. Some edge ponding is present on the southern side parallel to the road. The area between the field play area and roadway on the north and south sides is void of a barrier. There is a lack of a safety zone in the south east of the area beyond the end line of the field which is currently very close to the abutting parking lot. There is a small set of bleachers for seating but it is understood that this is adequate for the game needs.

As discussed in the Existing Conditions Evaluation (2.3.6), the turf is in fair condition, but it shows signs of wear. For the field turf area we recommend replacing the turf with sod; however a lower cost alternative to that would be over-seeding grass, allowing it to rest for a couple of months while using a Water Reel Irrigator to help establish and maintain a healthy turf. Chazen also recommends adding trees along the roads to the north and south, supplementing what is there, to act as a passive barrier, provide additional shade for spectators and improve the aesthetics of the field area.

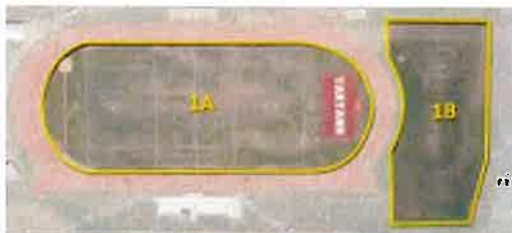
3.1.1 Field 1: Varsity Main Field

Field 1A - The major objective for the varsity field area is to raise the level of quality and performance of what is the most prominent facility in the School District to levels commensurate with its expectations.

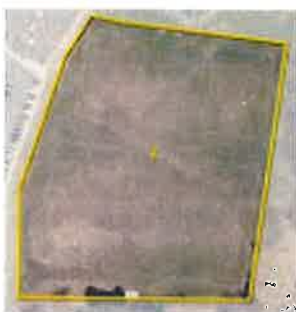
3.1.2 Field 2: Multi-Use Field

Chazen assessed several options for improving the multi-sport (field hockey and lacrosse) and physical education field. The major objective is to repair and establish viable turf which is currently in poor condition.

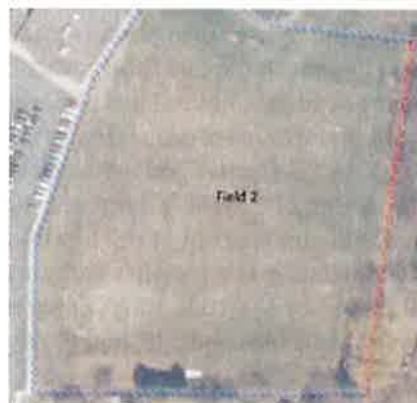
unknowing trespass beyond the school property line. Other notable improvements which Chazen recommends is the purchase of 4 new 4-row portable 14' aluminum bleachers (capacity 40 each), and the purchase of 2 new portable scoreboards for field hockey and lacrosse.

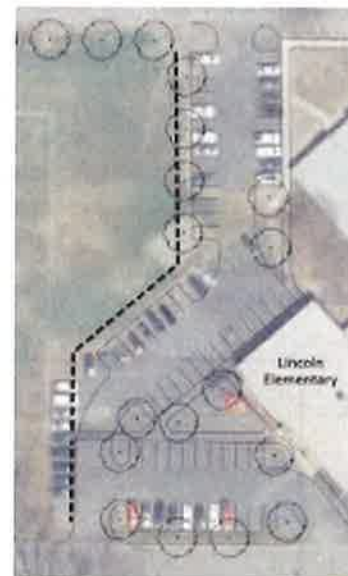
Figure 3 – Alternate Site Design

Please note that there is a current potential field play safety condition to consider. Under the current parking layout there is a significant pinch point resulting in undesirable vehicular conflict with the field and athletes (see figure 3). This raises two significant issues, first there isn't adequate run-out space for the athletes who use the field which is a field play/safety concern, and second the potential for property damage exists for any vehicles parked in these spaces as lacrosse practices or games are underway. Re-designing and re-constructing the parking layout to a more efficient design (see figure 4) which focuses on pedestrian safety and vehicular movement seems feasible. This would result in athlete's safe playing conditions by providing a run-off space of 20', increases pedestrian / student safety as the move from the school onto the field for recess and vice versa as entry and exit to the field will be guided towards a gate in a perimeter fence (dashed line). This plan would increase the efficiency and amount of available parking for teachers and visitors while improving the level of safety for the sports field users.

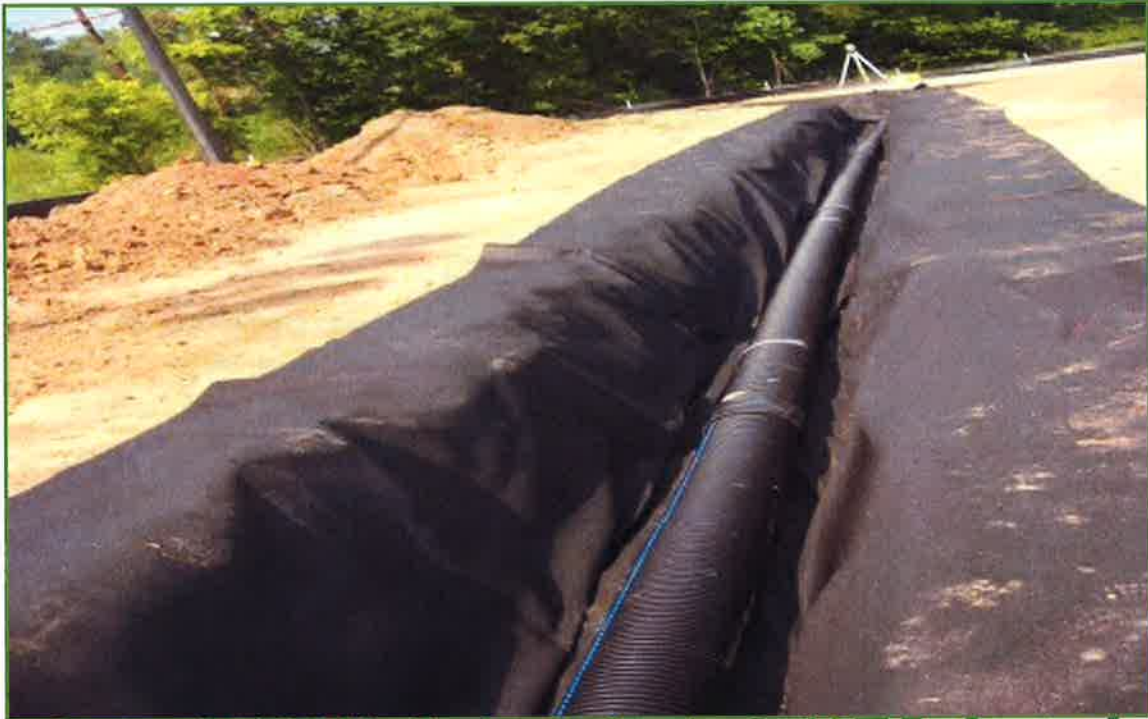
BASE AND DRAINAGE SYSTEM DETAIL

Synthetic Field Development Profile

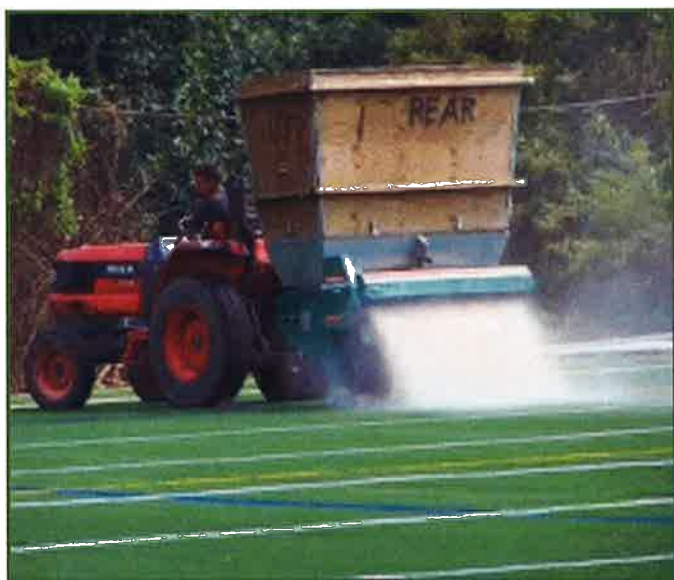
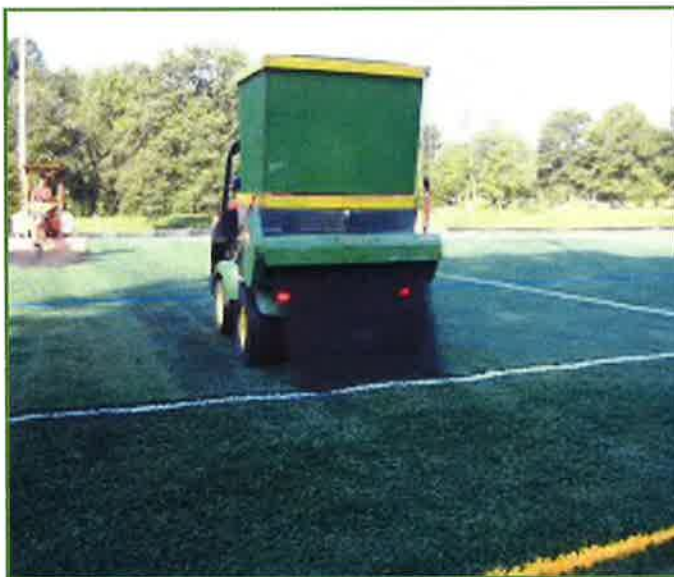
Installing Infill Materials

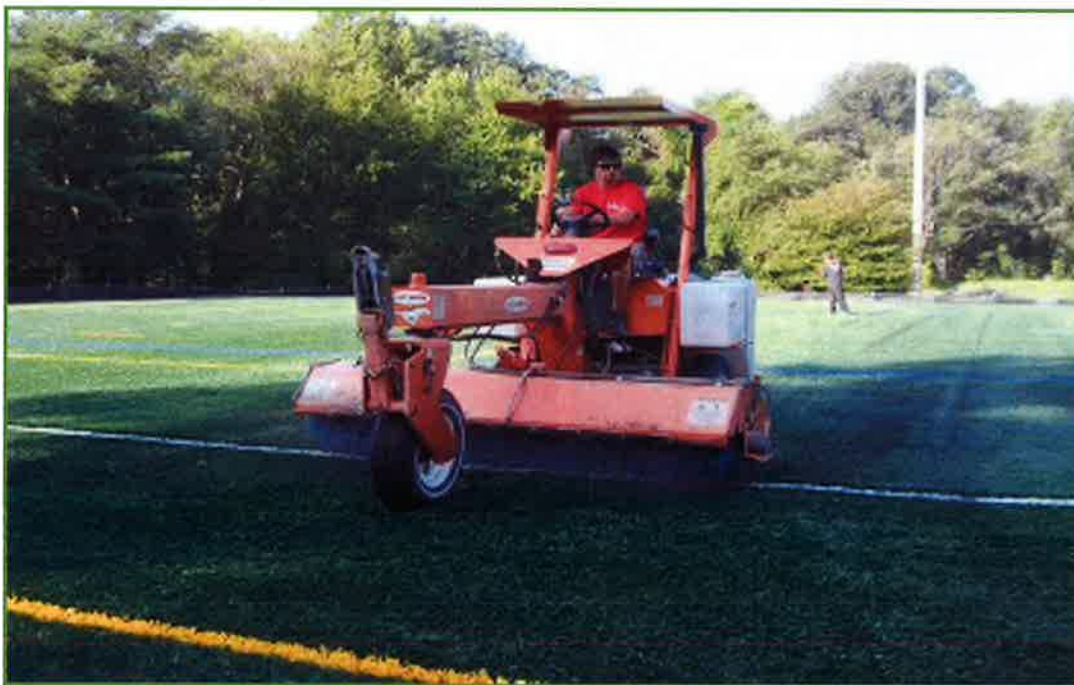
Brushing Infill Material

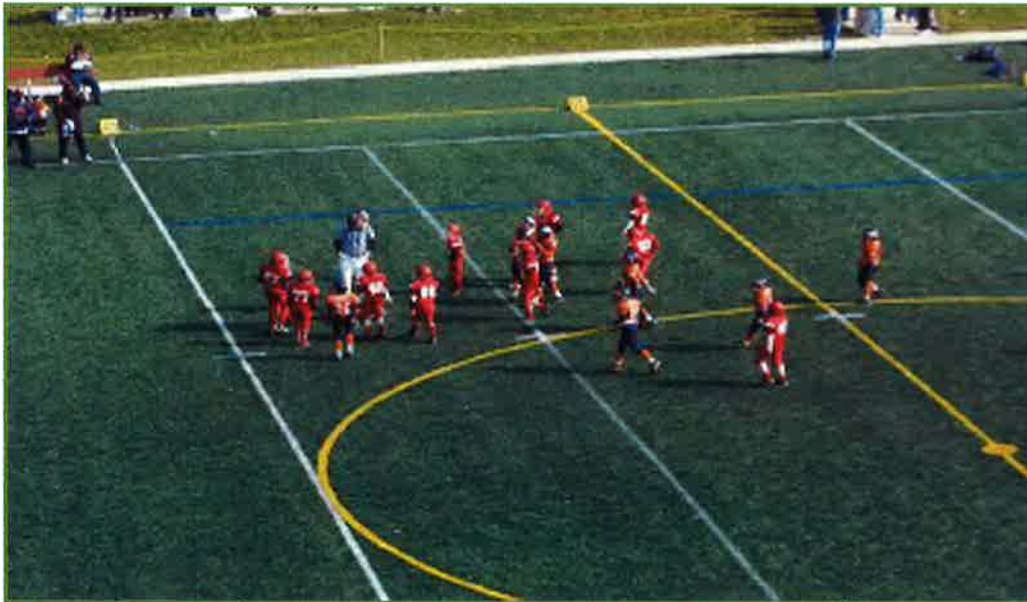
Completed Field With Inlays
